## CONDITION SURVEY AND RECOMMENDATIONS REGARDING THE REPAIR OF THE FACADES OF THE HISTORICAL BUILDING IN THE BESARABSKYI QUARTER IN KYIV

### Abstract

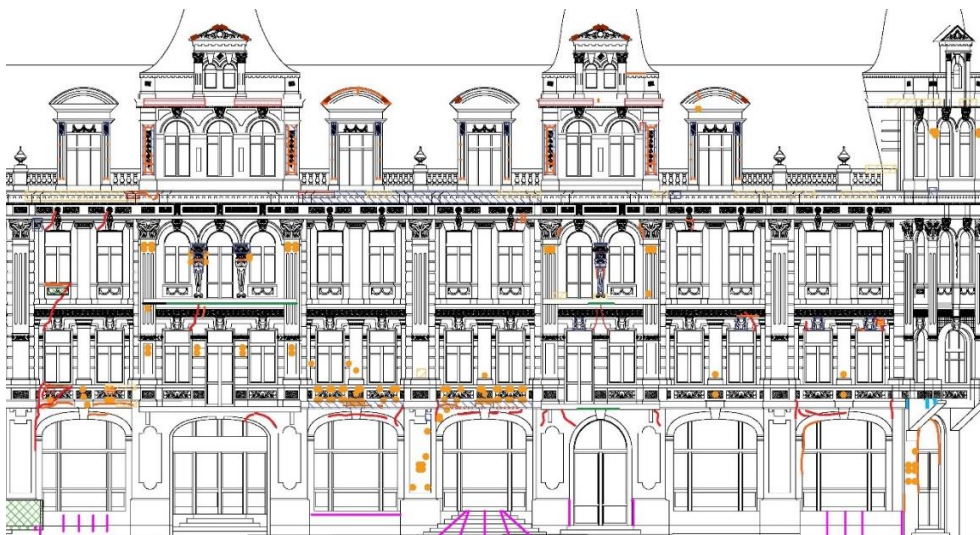
The condition of the structures was determined by visual and instrumental inspection, taking into account the defects and damage (Figs. 5 and 6) that were detected during the visual inspection, as well as their quantitative and qualitative indicators, as well as the physical and mechanical characteristics of the structures under inspection. Thus, it can be stated that the examined part of the walls of the facades of building 1-3/2 at the corner of Velyka Vasylkivska and Basseina streets in Kyiv can be classified as technical condition 3 – unsuitable for normal operation.

Fig. 5. A fragment of the facade of the building with applied defects and damage.

In case of local restoration of defects and damages, obvious defects and damages that can be seen visually on the facade are subject to restoration (Figs. 5 and 6).

It is recommended to repair the force cracks of the facade by "stitching" them. This is achieved by inserting high-strength steel rods into the body of the structure, perpendicular to the

Damaged areas of the facade decoration must be removed, after which a new decoration layer of plaster should be placed in their place. In order for the color and texture of the plaster to match the appearance of the main part of the facade, it is planned to paint the plaster with the subsequent application of imitation brickwork seams.

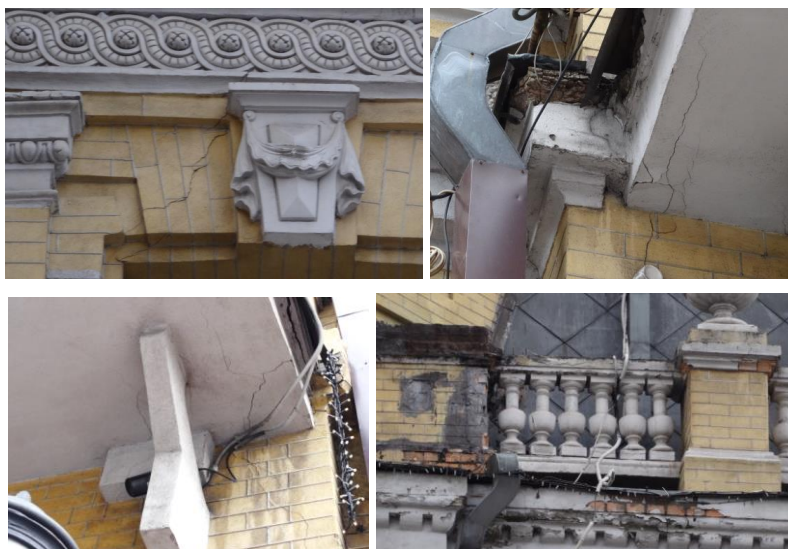
Fig. 6. Typical facade damages. Photos by Oleksandr Molodid, 2021
