ANALYSIS OF FLOOR DEFECTS IN THE HISTORICAL BUILDINGS OF
POLTAVA

Semko O.V., Filonenko A.A.

The Department of Civil and Environmental Engineering conducts inspections of facilities in Poltava region. The last of them was the Land Bank Building in Poltava. The building was built in 1901 on Pershotravnevyyi Avenue. It was designed by architect O. Shyrshov in the French-Italian Renaissance style. The building is two-story. It has walled structural system with a cold attic. There is a basement under part of the building.

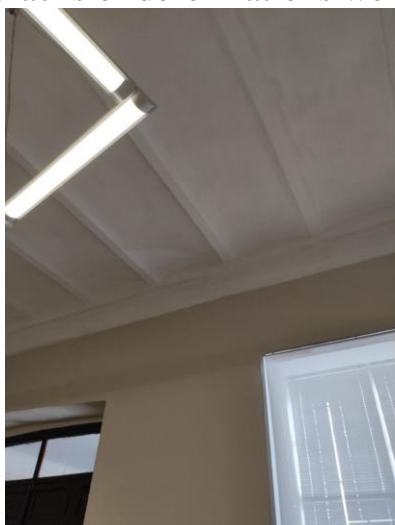
During the inspection of the historic building, the typical types of overlaps were found. The ceilings of the first and second floors are partially made on steel beams of I-beam №40, along which cylindrical brick vaults are arranged (Photo 1). The spacing of the metal beams is 800-900 mm. The ceilings of the basements and corridors of the first and second floors are made in the form of cylindrical brick vaults with support on two opposite sides of the room (Photo 2).

Photo 1. Ceiling on metal beams with a brick vault

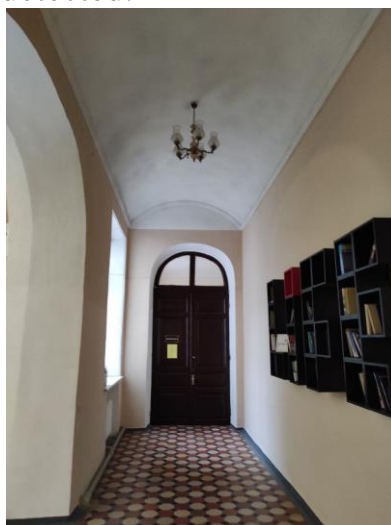
Photo 2. Cylindrical vault in the corridor of the Land Bank Building

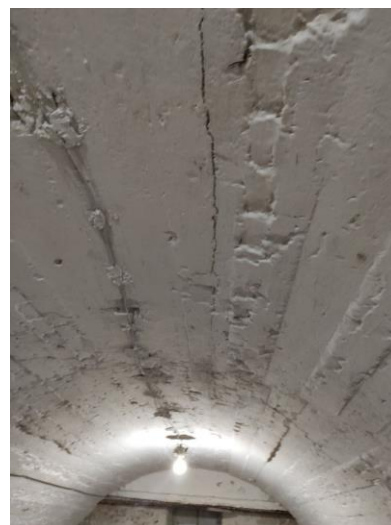
The most common defects in brick vaults are cracks caused by the destruction of bricks, due to wet and cold conditions, uneven settling of walls, and deformation of beams (Photo 3).

Photo 3. Cracks in the cylindrical vaults in the basement of the Land Bank Building

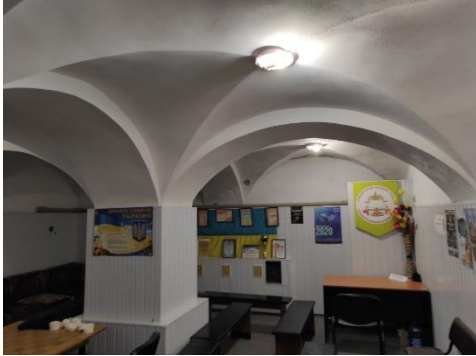
In part of the rooms, the ceiling consists of cross vaults with point support in the corners (Photos 4.5). The technical condition of the cross vaults is satisfactory. No cracks or deformations were detected.

Photo 4. Cross vaulted ceiling in the basement of the Land Bank Building

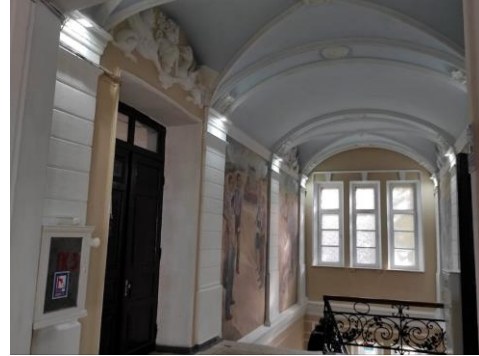
Photo 5. The cross vault in the Land Bank Building

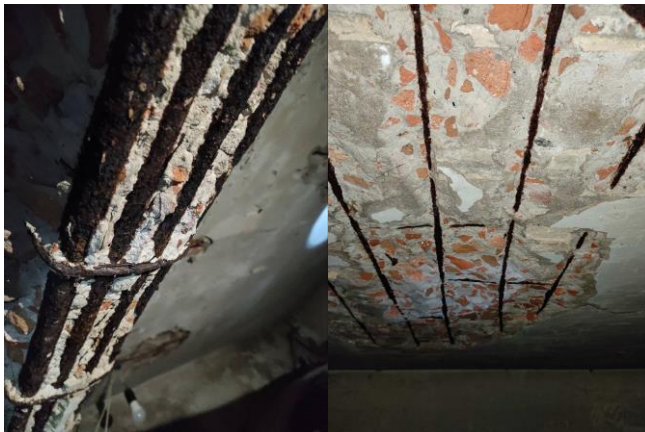
Some of the main purpose have monolithic steel reinforced concrete ceilings. The main defects include corrosion of reinforcement up to 100% of the cross-section and delamination of the protective layer of concrete (Photo 6). Corrosion of metal elements occurs due to a wet environment, lack of ventilation and improper maintenance (Photo 7).

Photo 6. Corrosion of metal elements in the basement of the Administrative Building in Poltava

The research has identified the main types of overlaps in historical buildings: cylindrical and cross vaults, monolithic concrete, brick and concrete, and wooden. The main factors that determine the technical condition of the overlapping include uneven settlement of vertical load-bearing elements and violations of the temperature and wet conditions. It is recommended to prevent moisture in the foundation zone of buildings and repair the organized drainage system, as well as restore the temperature and humidity conditions of the overlaps.

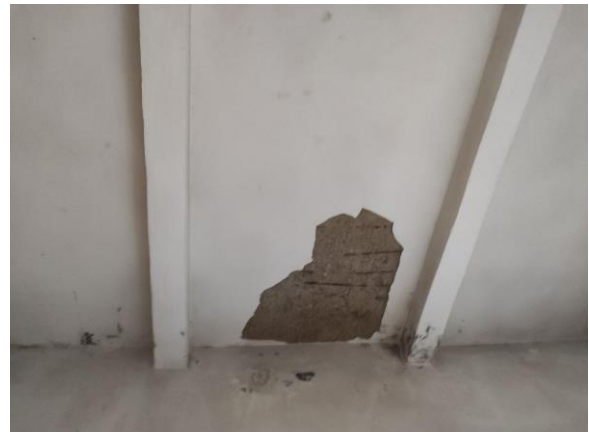
Photo 7. Detachment of the protective layer of concrete
