ROAD SUBGRADE DEFORMATIONS ANALYZING

Monitoring of 23 Ukraine regions revealed that major part of abnormal subgrade deformations have highway embankments higher 21 m. According to the monitoring results, a comparison histogram of malformed embankment amount to their total value was drawn. The main causes of road subgrade deformations are analyzed.

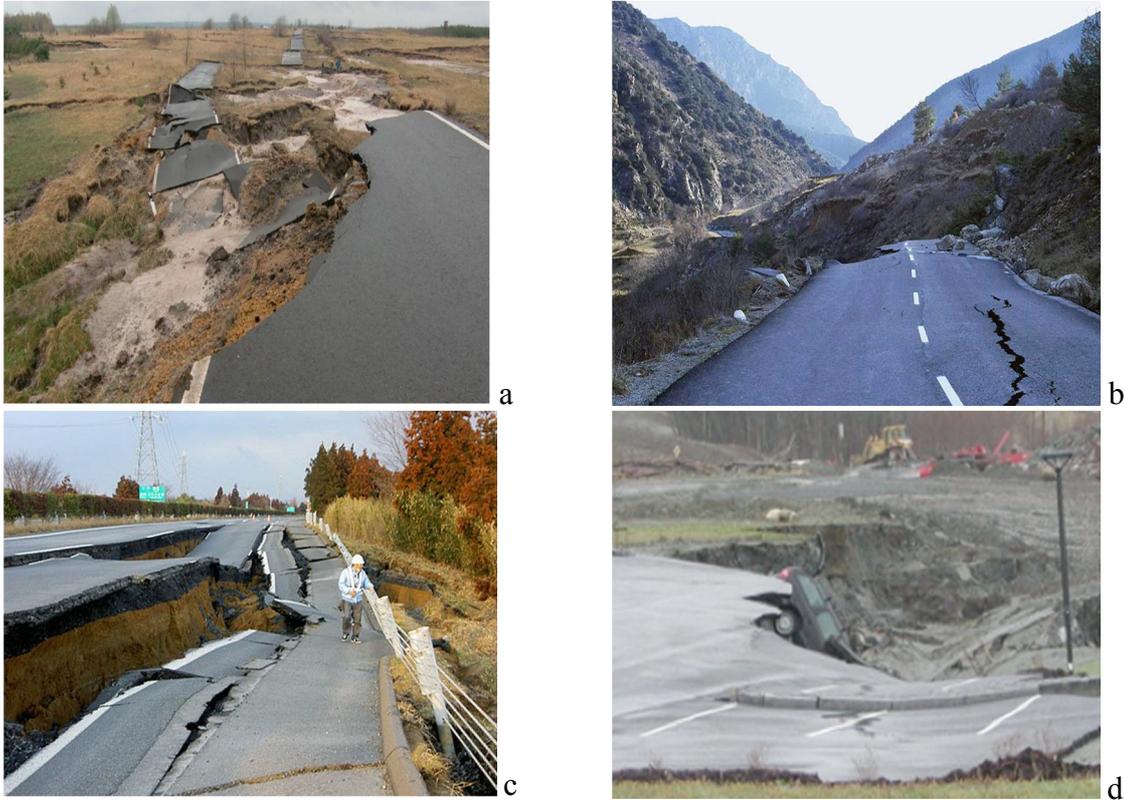
Embankment subsidence caused by soils consolidation from which it was erected is wide-spread (Fig. 2, c). Subsidence appears when soils was compacted insufficiently. The reason may be the difference in the filtration rates of soils and through the blocks of ice and snow in an array of frozen soil [3, 4]. Soil settlement (Fig. 2, d) takes place due to the insufficient strength and high deformability of base on which the embankment is arranged [5].

These deformations do not cover all destruction cases. Thus typical slopes damages, ablations that occur due to atmospheric precipitation, periodic soil freezing and defrostation, insufficient slopes strengthening, reloading of soils, violations of drainage. When upper soil layer was defrosting, the embankment contains a significant water amount. Its moisture may exceeds the liquid limit, and soil slows down by slope [3 – 5].

Figure 1 – Road subgrade deformations [6]:
 a – flow liquefaction;
 b – longitudinal cracks near the edge of pavement
 c – soil settlement
 d – embankment subsidence
