PRESERVATION AND RESTORATION ISSUES OF THE SALESIAN MONASTERY FAÇADE IN OŚWIĘCIM: LESSONS FROM UKRAINIAN PRACTICE

In 2021, a program of conservation works was developed on the external facades of the Sanctuary of Our Lady of Memory of the Faithful in Oświęcim. The company from Cracow, "Markon – Konserwacja Zabytków," carried out the program of conservation works and condition studies.

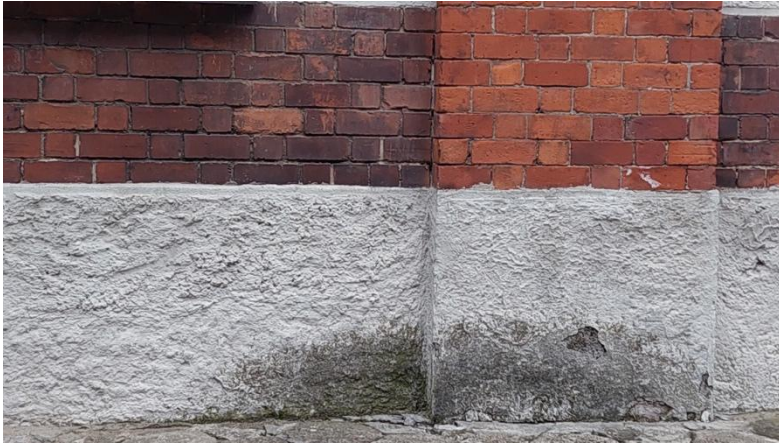
Fig. 2. Moisturizing and salinization of the wall.

In the scope of brick bonds, it was first proposed to examine their condition and clean them to remove dirt. It is proposed to apply appropriate chemical components from Remmers or Henkel to the designated damp fragments. After this work, the destructive bricks and joints should be removed, and the remaining parts of the brick bonds should be strengthened with a Remmers preparation. The removed bricks should be replaced with new bricks of similar characteristics. Small places where bricks are missing should be filled with a colored mineral putty. It is also proposed to enrich the lime-sand mortar with a hydraulic additive.

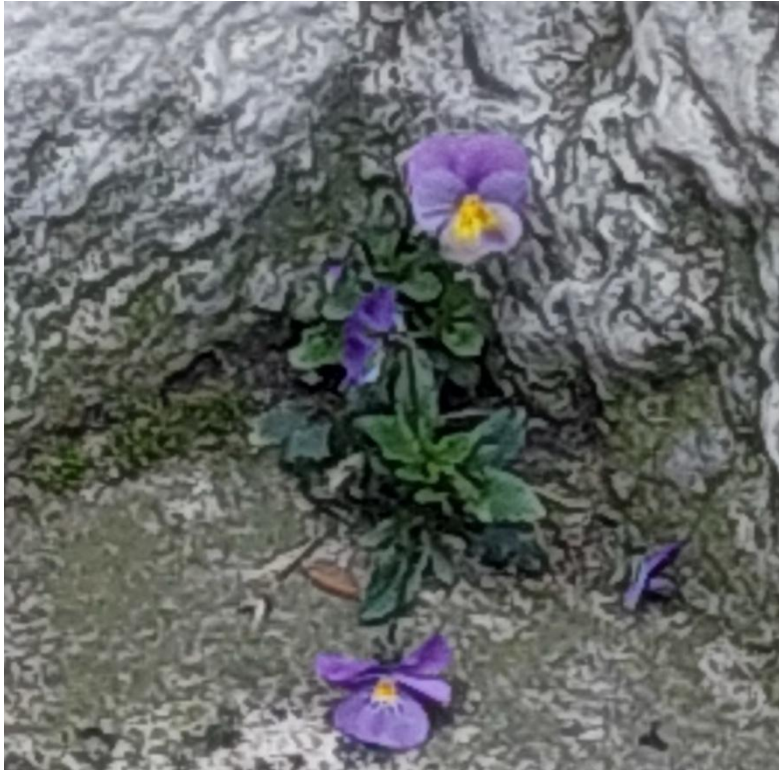
Fig. 2. Biological damage to the lower part of the walls.

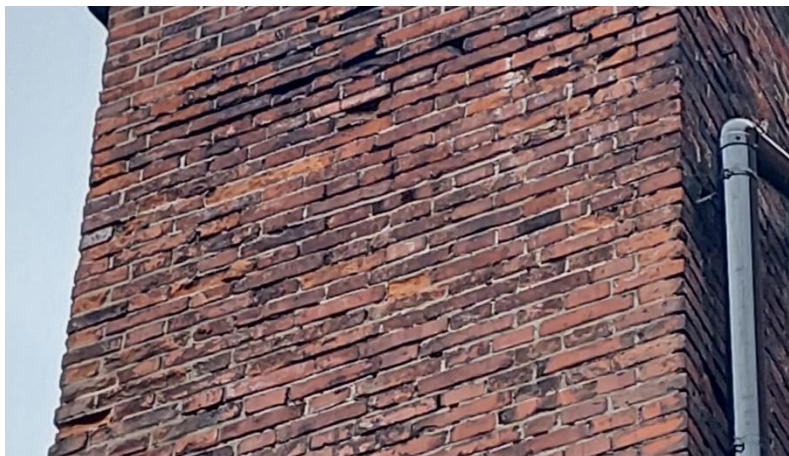
Fig. 4. Defects in brickwork caused by temperature and humidity fluctuations.

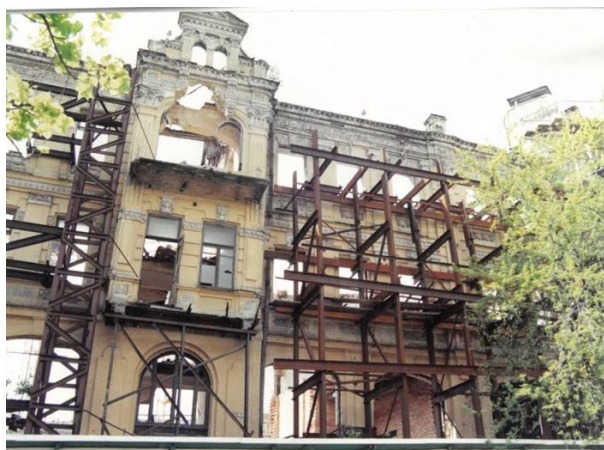
The main problems of the emergency state of the walls were associated with the appearance of through cracks, destruction of the masonry mortar, damage and contamination of bricks and rows of masonry with peeling plaster and moisture, and biodegradation. The main cause of the emergency state of the building was uneven subsidence of the foundations and substructures, which led to deformation of the walls and the heels of wooden columns and beams; subsidence reached 25-32 cm in some places. The causes of the emergency state were atmospheric moisture from paving, temperature drops, and impaired drainage.

Fig. 7. Condition of the walls of a building in the Bessarabskyi quarter in Kyiv before the start of restoration (2001)

Restoration measures were aimed at eliminating the deformation of the foundations (the foundations and substructures were reinforced with bored piles). The old roof covering was replaced, and the load from the roof and ceiling was transferred from the old wooden columns to the brick walls. The brick plinth, brick surfaces, and brick decor between the plinth and the crowning cornice were restored, and the brick surfaces of the ends were restored. The emergency condition of the walls of the Bessarabskyi quarter was caused by waterlogging of the substructures and foundations and the destruction of the roof and ceilings. The methods of strengthening the walls were as follows: corsets made of metal ties were placed on the historical “frames” of the emergency walls, which tightened the walls with numerous cracks. In addition, the walls were reinforced with a metal mesh, on top of which a concrete “jacket” was placed (Figs. 6-8).
