ISSUES AND METHODS OF RESTORATION OF KYIVAN RUS PERIOD FOUNDATION MASONRY

Mykola ORLENKO¹, Yulia IVASHKO², Dominika KUŚNIERZ-KRUPA³,
Ivan BUZIN¹, Andrii DMYTRENKO^{4*}, Jan MAGIERA³

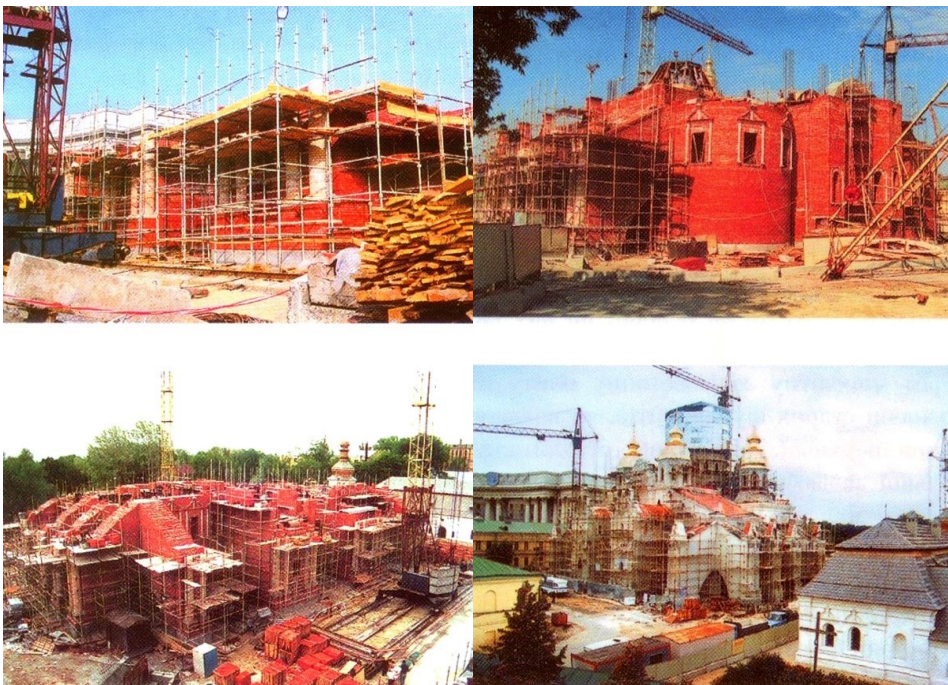
Fig. 3. The reproduction process of the St. Michael's Golden-Domed Cathedral.
From the archive of Ukrrestavratsiia Corporation.

In the final option, root piles, bored piles and jacked piles were used to reinforce the old foundations and to transfer loads from the reinforced concrete grillage, that provides joint flexible operation of the existing foundations and piles to the lower reliable soil layers. The root piles were installed next to the old footings; it was possible to ensure the reliability of the wall and access to old foundations through special holes in the grillage slab. The root piles with a diameter of 500 mm were used in the central part of the cathedral, that carries the most massive load; the bored piles with a diameter of 200 mm and jacked piles were used in the aisles (Figs. 2 and 3).

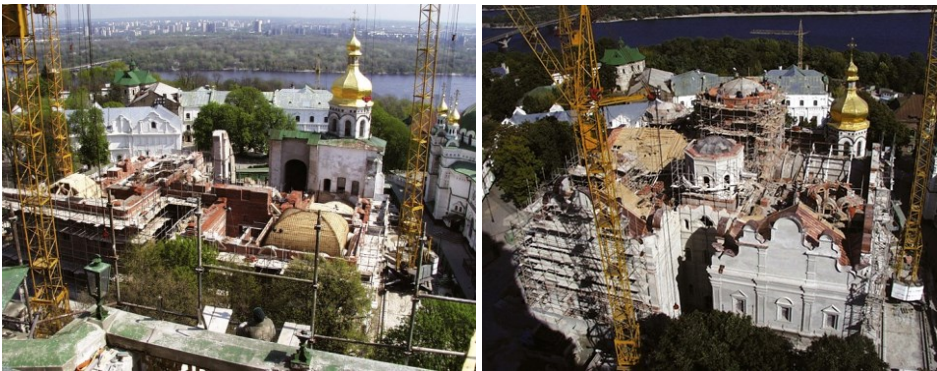
Fig. 7. The process of reproduction of the Assumption Cathedral. [the archive of Ukrrestavratsiia Corporation]

Taking into account the difficult geological conditions (the presence of loess soils under the foundations of the Assumption Cathedral), it was decided to pass the piles through the existing rubble foundations without touching the burial. Due to the significant complexity of the work on their implementation, only specialists from Ukrrestavratsiia Corporation undertook. They drilled the authentic foundations of the central part of the Assumption Cathedral by crushing the piles in metal casing pipes, without disturbing the "cultural layer" with a large number of burials (Figs. 6 and 7).

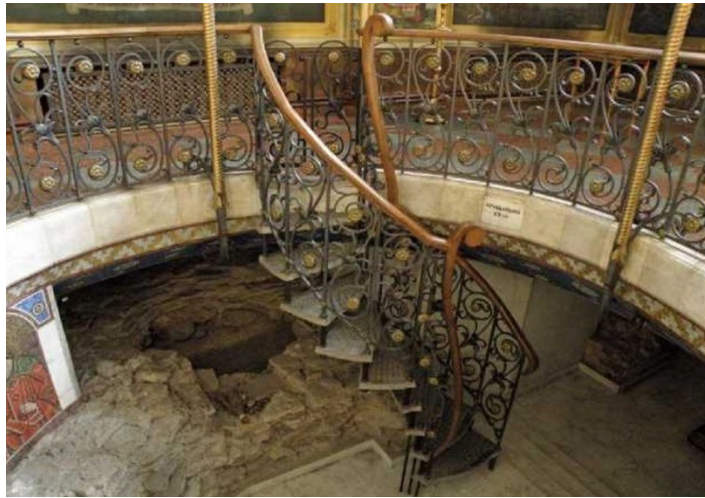
Fig. 8. The fragment of the monolithic reinforced concrete raft.
[the archive of Ukrrestavratsiia Corporation]

In figures 8 and 9 are presented two examples of monolithic reinforced concrete raft, respectively Assumption Cathedral of Kyiv-Pechersk Lavra after the works.

In the St. Michael's Golden-Domed Cathedral, bored piles (in the central part of the cathedral), bored injections and piles and jacked piles (in the side aisles) were arranged next to the authentic foundations, and on top of them, there was a monolithic reinforced concrete slab with

holes for further museumification of the foundations (Fig. 8).
