The Work of Stone Pillars Damaged During Operation

During the experimental and statistical research the experiment was planned for the three most important factors influencing the residual load-bearing capacity of damaged stone columns rectangular cross section, namely, the depth of damage, the angle of the front damage on one of the main sections of soy and eccentricity. Numerical modeling of work of the eccentrically compressed rectangular cross section damaged during the operation of stone pillars was carried out in the LIRA-SAPR software package in a non-linear environment. The results of experimental statistical modeling made it possible to determine the influence on the throughput of each of the selected factors, as well as the mutual influence of the factors. Based on the obtained values of the destructive force for 15 column marks, in accordance with the experimental design, a three-factor experimental-statistical model of the second order was constructed. This model is adequate to the experimental error of 0.45, with 7 statistically significant factors. The analysis of the above method of calculating the damaged stone pillar in PC LIRA allows us to conclude that this meth

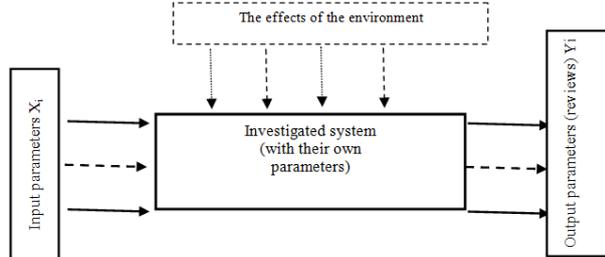
Fig. 2: Statistical model of the experiment

Given that the accepted model of the experiment is manageable, it can be schematically described using a black box model, the internal device of which is unknown, and only its inputs X_i and Y_i outputs are investigated and thus the external environment is stabilized (Fig. 2).

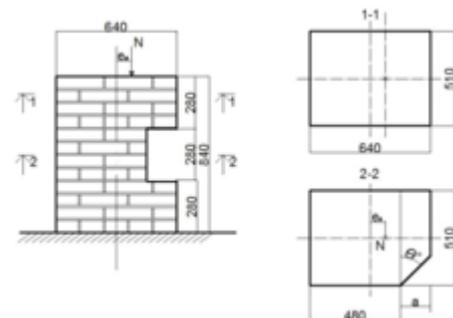
Fig. 3: Scheme for modeling of damaged sample-pillar

The obtained set of states of the investigated system allows us to analyze the dependence of the initial parameter of the bearing capacity of the samples on the determined factors x_1, x_2 i x_3 (Fig. 3).

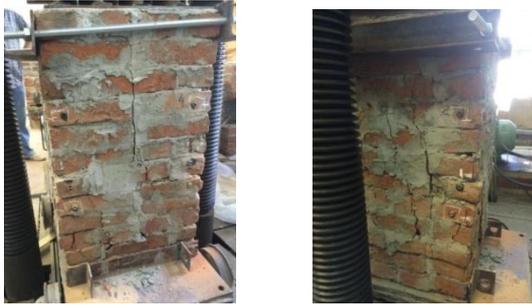
Fig. 4: Testing of a prototype of a pillar C -1 -1 -1 and a twin sample C 1 -1 -1 with a central compression

During the loading process, the deflection from the load was measured, which was fed stepwise, as well as the appearance of cracks and their opening. The fig.4 shows the destruction of the prototype pillar -1 -1 -1 with central compression. With a longitudinal external force equal to $N = 50$ tf, at the loading level ($N/N_u = 0,71$), the main cracks appeared, which opened with increasing load. The nature of the cracks, the angle of inclination and their location are normal and expected. The destruction occurred after the load was held at $N = 70,035$ tf, with subsequent loading, small longitudinal cracks appeared to open and the structure ceased to take on any further load.

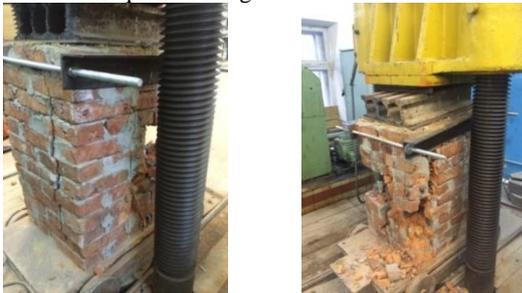
Fig. 6: Testing of the prototype of the column C 1 1 1

With the magnitude of the eccentricity of the applied load (up to 160 mm) and the depth of the damage (up to 320 mm), the bearing capacity of the damaged pillars is reduced, as shown in Fig. 6 when the load of the column 1 1 + 1 is loaded at a total $N = 6.67$ tf, which was $N/N_u = 0,71$ from the devastating load. During the

endurance of the load, the main longitudinal cracks followed, and the layering of the structural element under the applied load began to occur. The final destruction of the structure and the failure to perceive the loads occurred after the shutdown and subsequent loading to $N = 9.338$ tf.

With the magnitude of the eccentricity of the applied load (up to 160 mm) and the depth of the damage (up to 320 mm), the bearing capacity of the damaged pillars is reduced, as shown in Fig. 6 when the load of the column 1 1 + 1 is loaded at a total $N = 6.67$ tf, which was $N/N_u = 0,71$ from the devastating load. During the endurance of the load, the main longitudinal cracks followed, and the layering of the structural element under the applied load began to occur. The final destruction of the structure and the failure to perceive the loads occurred after the shutdown and subsequent loading to $N = 9.338$ tf.

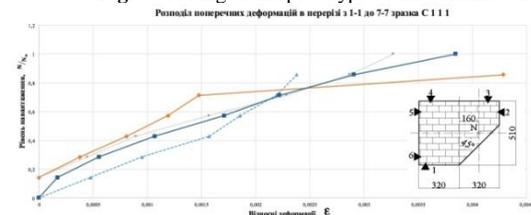
Fig.7: Deformations in the masonry of C 1 1 1

As seen in Fig. 7 with the test of the sample 1 0 0, large stresses occur at the boundary with the sensors 6, 7, 8 from the load applied with the eccentricity. In the region of the sensor fixation, longitudinal cracks became characteristic and indicative, wide open. Also, in the sample, a change in the "sign" was observed before the value of the arising deformations. The entire design undergoes compression, but because of the displacement of the eccentricity, the facet with the 3,4 sensors works by stretching. This phenomenon is explained by the fact that the structure is bent

under pressure, but as the stone structures do not work well, a break occurs soon. Destruction occurs at $N = 30,682$ tf.

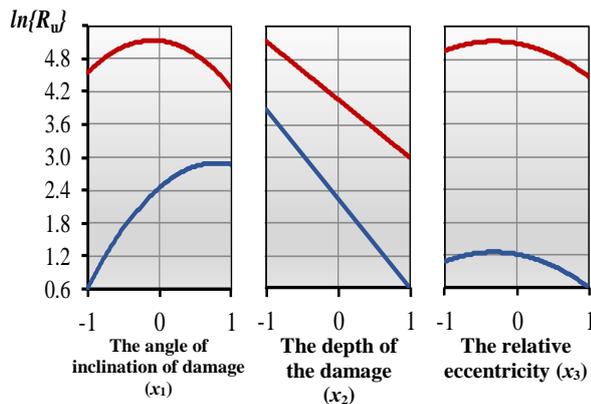
Fig. 10: One-factor dependences of influence of variation of input factors on destructive loading

According from the estimations of the ES-model and single-factor local fields (Fig. 10), the significant influence on R_u makes X_2 with the increase of the depth of damage in the section of the column significantly decreases the destructive load, so in the zone of maximum values of 8.5 times.

From the analysis of the model it follows: the limiting load of sample pillars depends on the magnitude of the angle of inclination of the front of the damage x_1 , and on the relative eccentricity x_3 . So, with an increase in the eccentricity e_0/h (assuming $x_1=-1$) of the applied load, R_u first grows by about 18% for $x_3=-0.40$, and then decreases by about 47% for $x_3=+1$. Influence of the angle of inclination of the front of the damage (provided $x_3=-1$) on the external load is slightly larger. With the change of X_1 from 0 to

$22.5^\circ R_u$ increases by 79%, and with further change of X_1 from 22.5° to 45° , the destructive load decreases more than 2 times (from 140.9 to 59.7 tf).

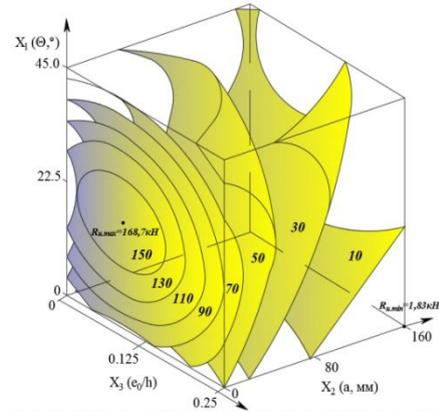
Fig. 11: Influence X_1-X_3 on the destructive loading of the pillars

The analysis of the presented diagram (Fig. 11) constructed on the three-factor model (2) shows that the pillars can withstand the maximum load in $R_u=167.1$ tf, but only if the angle of inclination of the front of the damage (X_1) is about $18-22.5^\circ$, and the relative eccentricity (X_3) will be about $1/8$ of the applied load.

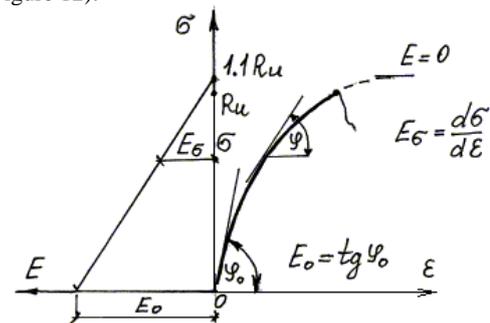
Fig. 12: The deformation pattern of the masonry

According to the current norms, on the proposal of L. I. Onishchik diagram of "stress-deformation" for the masonry has the following form (Figure 12):

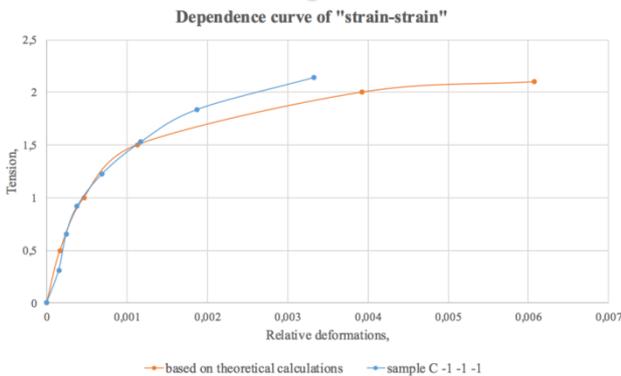
Fig. 13: Graph of tension and deformation

The resulting calculation results are presented in Fig. 13

The method of evaluation of residual bearing capacity in the software complex, non-destructive method is proposed hereafter. At the first stage, we create points on coordinates, which later connect and set the boundary conditions to nodes in five degrees of freedom. At the second stage, we set the stiffness of the elements. Using the "Hardness \rightarrow Hardness Elements" menu, we call the "Elemental Hardness" dialog. In this window, click on the "Add" button to display the list. Choose the third dialog "Plastic, Volume, Numerical", the type of section - "Volume Limit Elements", and then put a tick on the account of nonlinearity and press "parameters of the material", choose the "law of nonlinear deformation", in our case, it is 14 (piecewise -linear law of deformation), and then we introduce data on the characteristics of the material from the received graph of the dependence of "stress-deformation" (Fig. 13)

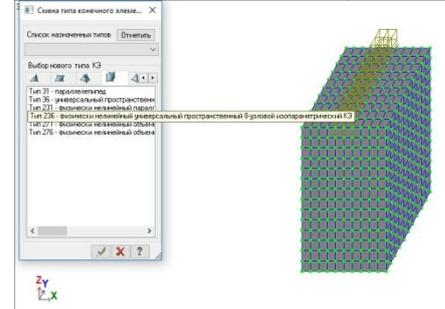
Fig. 14: Selecting the type of the final element

The laying was given by physically nonlinear spatial eight-node and six-node isoparametric KEs of type 236 - "physically nonlinear universal spatial 8-node isoperimetric Limit Elements " (Fig. 14) and a metal plate for the transfer of load 234, taking into account geometric and physical nonlinearity.

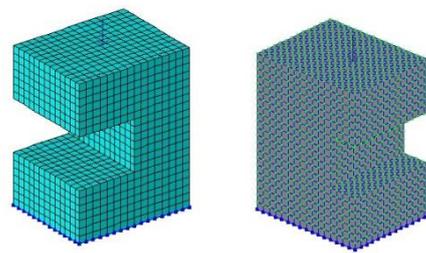
Fig. 15: Finite Element Model of a Damaged Column

The pillar was divided into finite elements in the form of rectangular parallelepipeds with a face dimension of 1 to 2 cm, as well as octal and six-node endpoints in the form of triangular and quadrangular prisms in places where this required the geometry of the

sample for modeling the slope of the shelves and the front of the damage.

The resulting model is close to a full-scale experiment (Fig.15,16,17). We perform the calculation of the model, and the results are obtained in tabular form.
