KEY ASPECTS ON DESALINATION IN HISTORIC BRICK MASONRY

Keywords: Desalination feature; Historical brickwork

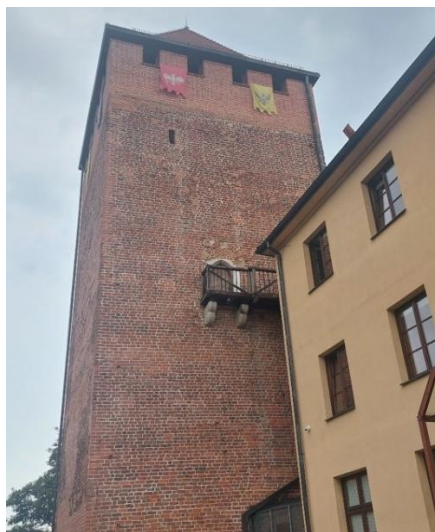
Fig. 1. Castle tower. Current state, 2024

Parts of the castle in Oświęcim have the following dating: tower – mid-13th-14th century; tunnels – 18th-20th century; representative part – 19th century (Fig. 1).

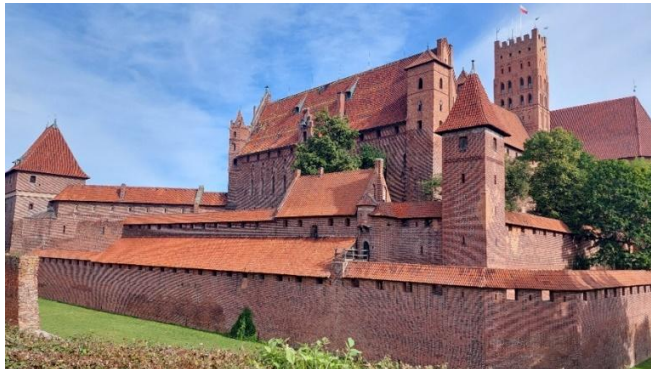
Fig. 2. General view of the castle in Malbork, 2025

Unlike the castle in Oświęcim, which consists of a single building with parts from different periods, the castle in Malbork actually consists of three castles combined into one complex: the High Castle, the Middle Castle, and the Low Castle (Przedzamcze) (Fig. 2).

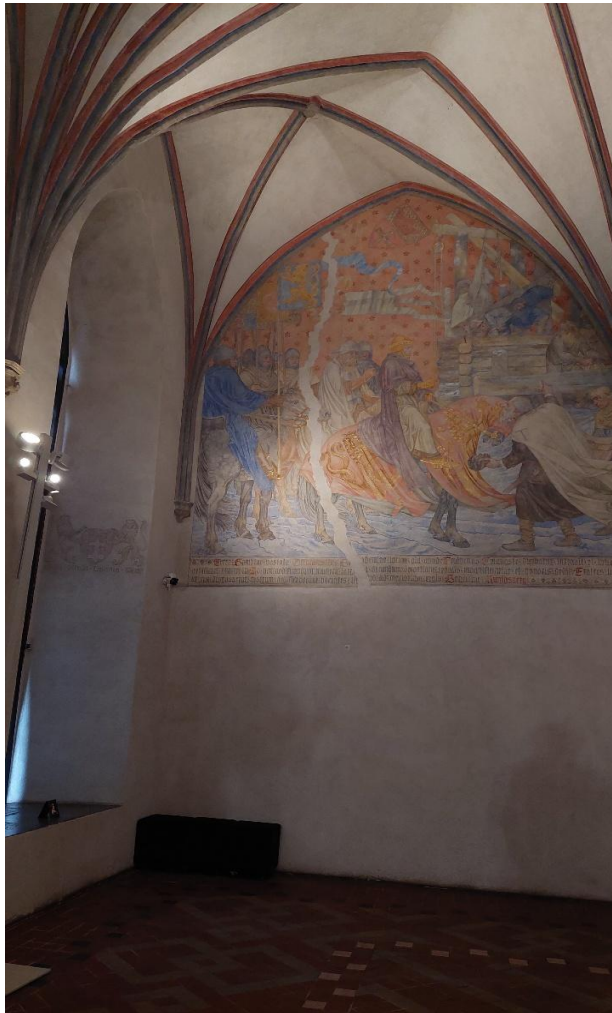
Fig. 4. Elimination of cracks on the premises of the Great Refektarz, 2025

Given the specifics of subsidence soils, there are cracks in the buildings of many castles on the riverside, the causes of which are being investigated. Separately, it should be said about the masonry of the walls of spiral staircases, pointed arches, and star-shaped Gothic vaults with ribs. Often, brickwork is supplemented with details made of natural and artificial stone. Cracks can be located curvilinearly, along the contours of the arch of the vault from top to bottom. Uneven subsidence of the walls with the appearance of cracks can cut through the mural (like the 19th-century mural in the main reception hall in the Middle Castle – the Great Refektarz) (Fig. 4).

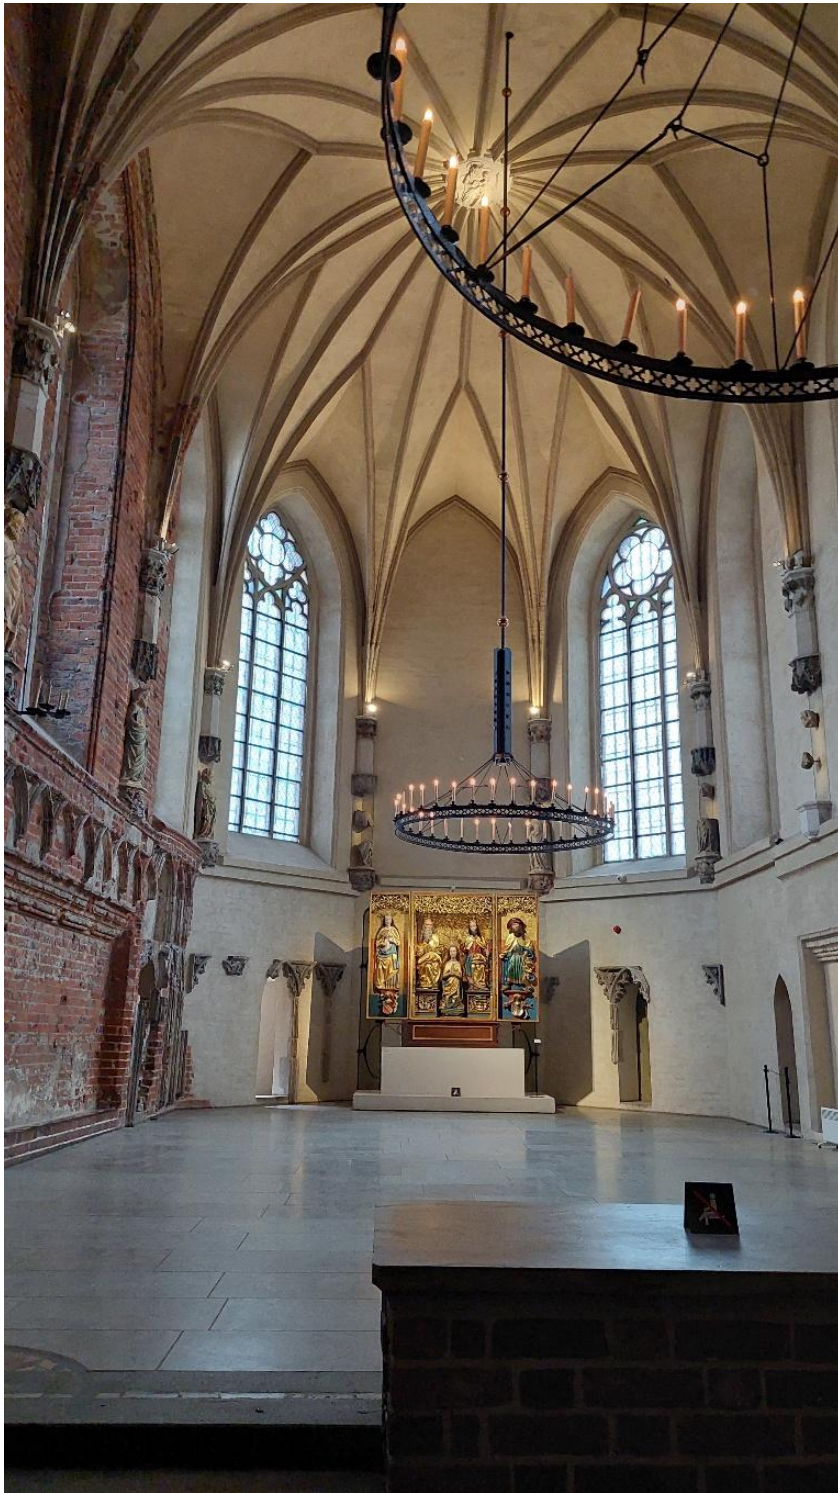
Fig. 5. Interior of the main temple with separation of the authentic and completed parts, 2025

In the main church of the castle, in the name of the Blessed Virgin Mary in the castle in Malbork, part of the walls and vaults are authentic, except for the altar, which, together with the figure of the Madonna, was destroyed by a tower that fell on it. Reconstruction work continued from the 1960s until 2016, when the Madonna was recreated with the inclusion of some authentic fragments of clothing. The authentic parts of the church were left unplastered; the supplemented parts were plastered to show their different time periods (Fig. 5).

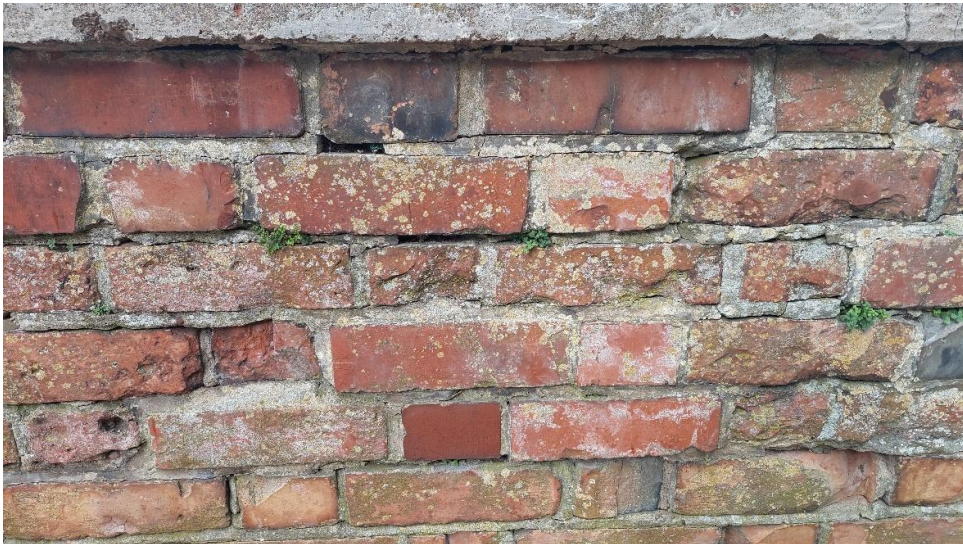
Fig. 7. Brickwork with salinization and biofouling, 2025

One of the methods involves the removal of water-soluble salts from the basement of the external walls of architectural monuments (Fig. 7).

Removing salts only from the surface layer of masonry and strengthening only the outer layer with hydrophobic substances does not solve the problem, since water-soluble salts remain inside the masonry. Specialists have developed a technology for desalination of the lower part of a brick wall 2-3 m above the ground surface in the absence of waterproofing and perimeter paving. The salinity level, salt composition, and causes of salinity (from groundwater, atmospheric pollution, etc.) are previously established.

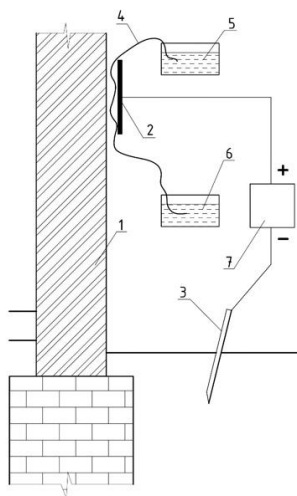
The schematic diagram of the device for removing water-soluble salts from wall masonry is shown in the scheme (Fig. 8). Along the upper edge of the wall section that is being de-energized at a height of 2–2.5 m from the ground level, a plate anode 0.2–0.5 m wide is installed, which can be made of sheet lead, aluminum, or other metal that has high resistance to electrochemical corrosion. The cathode must perform the function of grounding; it is in the soil adjacent to the foundation at a distance from the building. A compress made of cotton fabric with high porosity is placed between the anode and the brick wall. The upper end of the application is immersed in a tank with water, and the lower end is immersed in a tank for collecting the filtrate. The first tank is placed above, and the second is below the anode. The anode is connected to the positive pole of the DC source, and the cathode is connected to the negative pole.

Fig. 8. Schematic diagram of a device for extracting water-soluble salts (from the M. Orlenko collections):
1 – wall subject to desalination; 2 – lead plate – anode; 3 – cathode; 4 – fabric application; 5 – power tank; 6 – filtrate collection tank; 7 – DC source

The greatest effect of desalination at the level of the anode is achieved from the side of its location and in the lower rows of masonry – from the opposite side.

A sufficient condition for the end of the desalination process is to achieve a salt content that has an acceptable value in the lower zone of the wall at a depth of 5–10 cm from the side of the anode installation, which takes about 2–3 months.

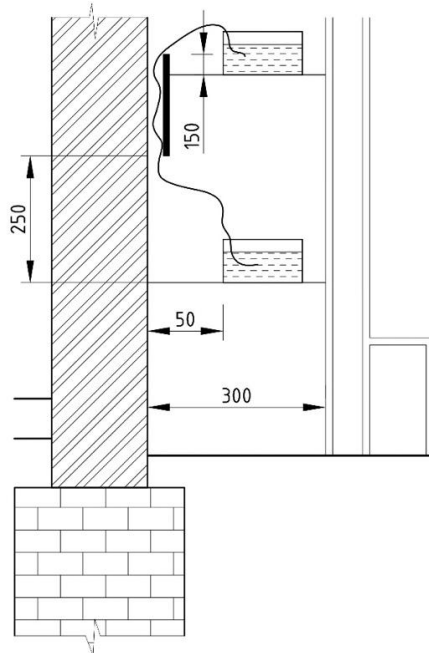
Fig. 9. Tank mounting scheme (from the M. Orlenko collections)

- inventory containers are installed on the shelves at a distance of 5–10 cm from the wall with the subsequent introduction of the ends of the compress into them;

- mount the cathode using the grounding method (three pipes driven into the ground, connected by a circuit of metal plates).

During the treatment process, a constant water level is maintained in the upper tank by adding water once a day, and as the filter accumulates, water is poured out of the lower tank. During the desalination process, records of work are kept under the guidance of a specialist, in which the instrument readings, time, and location of samples taken for control are recorded daily. The work is stopped at the instruction of the person responsible for the work based on the results

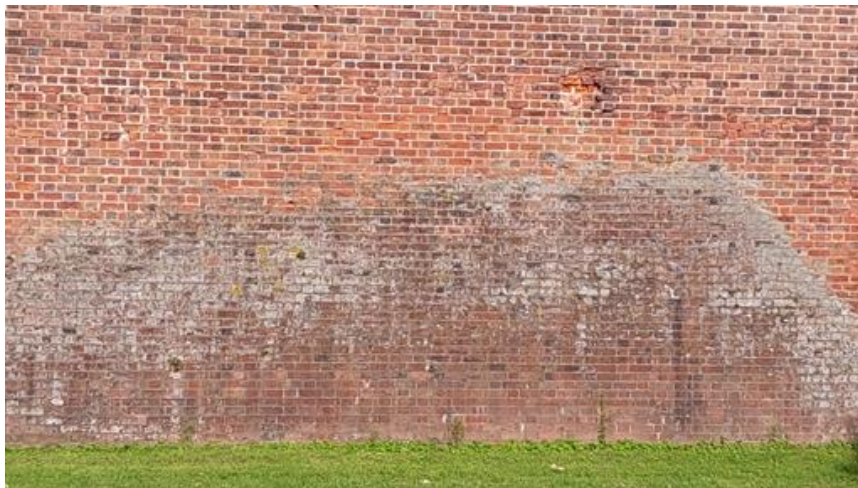
Fig. 10. Salinity at a considerable height of brickwork, 2025

If the wall is salted to a height of more than 3 m, several strips of anodes are used to accelerate the desalination process, located parallel to each other at a distance of 2–3 m (Fig. 10).
