**Citation:** Ivashko, Y., Ivashko, O., KUZMINA, H., DMYTRENKO, A., TWARDOWSKI, G., (2026). Features of the historical residential development of Kyiv Podil and modern problems of use, *Środowisko Mieszkaniowe/ Housing Environment*, 56, pp. 18–28, e2026010. <https://doi.org/10.2478/he-2026-0010>

# Features of the historical residential development of Kyiv Podil and modern problems of use

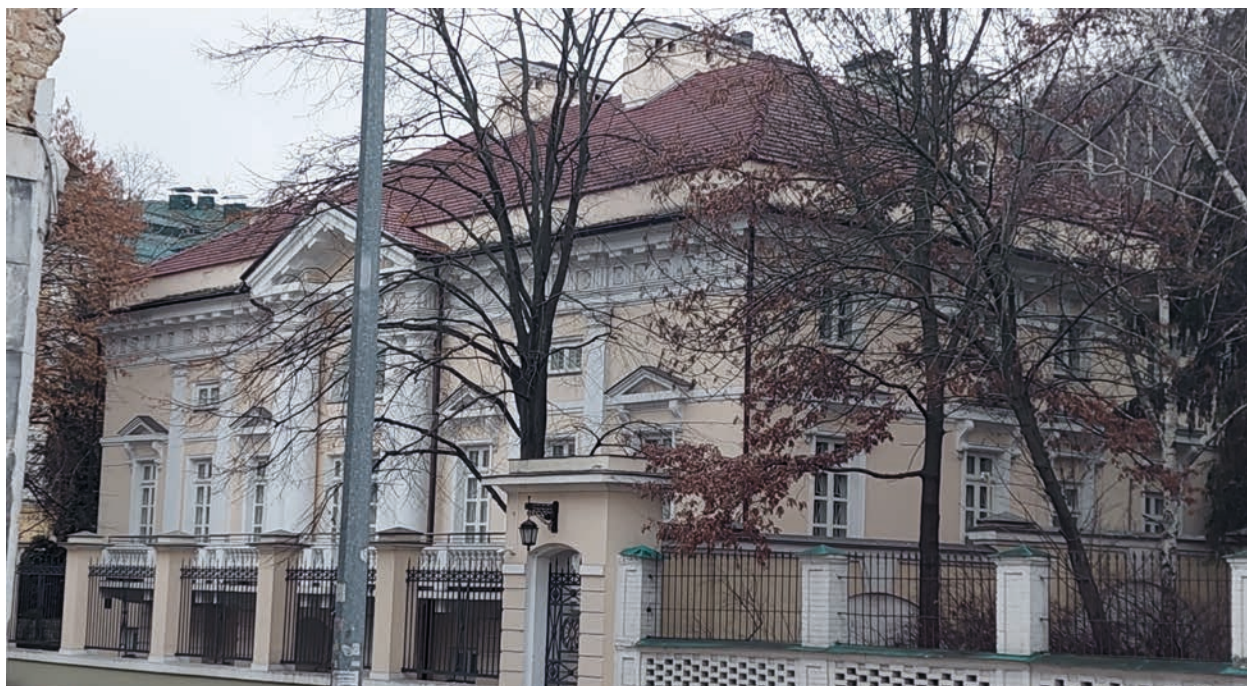
III. 2. Samson Strelbytskyi's house. Photo by Y. Ivashko, December 21, 2025

Among the few houses that survived the fire of 1811, one should mention house No. 5, which belonged to the jeweller Samson Strelbytskyi. This house was built in 1808 in the classicist style and is made of brick (III. 2).
